United Nations S/2023/81

## Letter dated 1 February 2023 from the Secretary-General addressed to the President of the Security Council

## NOTE BY THE TECHNICAL SECRETARIAT

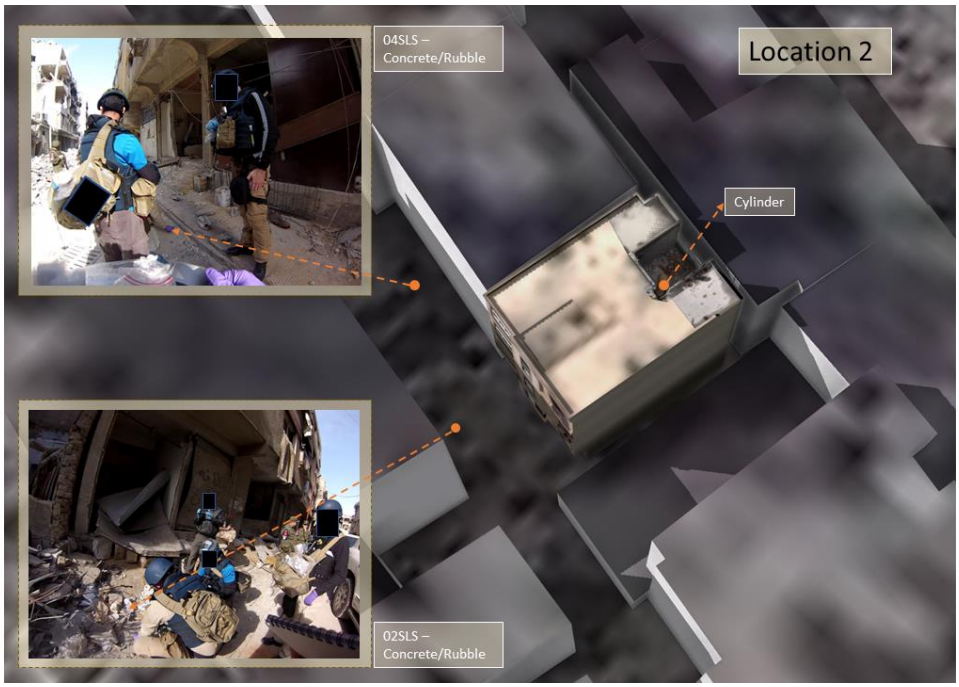
6.56 In a supporting study considered by the IIT, two concrete debris samples collected by the FFM—one across the street from the entrance to the building (02SLS) and one control sample collected 20 metres west of the entry to the building (04SLS)—were analysed. MCP and DCP were identified in sample 02SLS. The control sample 04SLS did not contain reportable levels of chlorinated phenols. The absence of highly chlorinated phenols in both samples suggests that the TCP and TeCP identified in the building were generated through the action of a chlorinating agent, such as chlorine gas, and not by the general contamination of the environment linked, for example, to the use of chlorinated phenols as pesticides.

**FIGURE 2: SAMPLES COLLECTED AT LOCATION 2 CONSIDERED BY THE IIT**

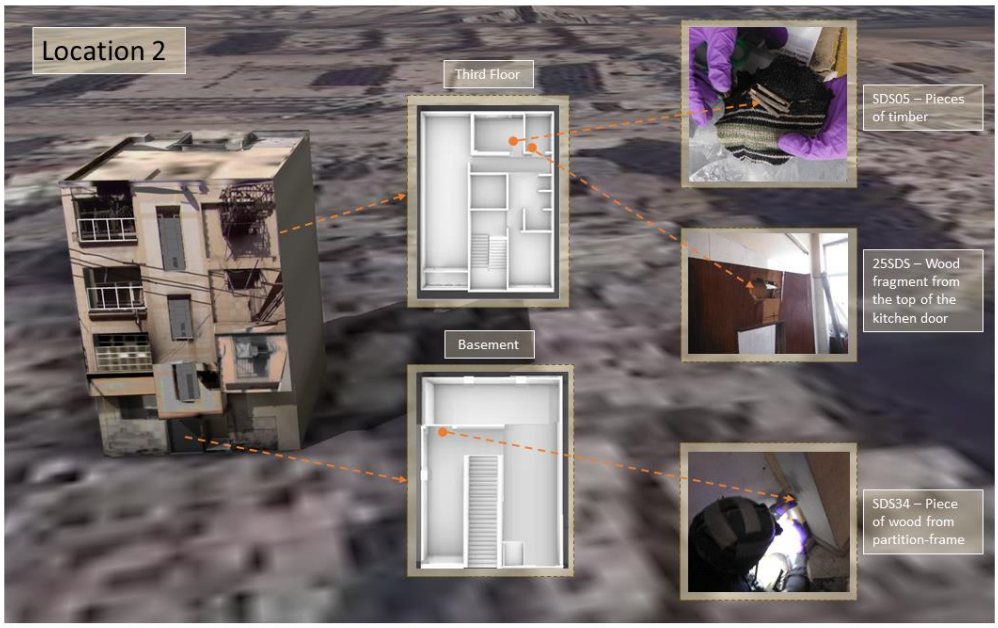
6.61 The chlorinated chemical TCP can be detected in all lignified woods after exposure to chlorine.[108] TCP was identified in a number of wood samples collected by the FFM, including pieces of timber on the floor in the room under the cylinder (SDS05), wood fragments from the top of the kitchen door (also on the third floor) (25SDS), and a piece of wood from a partition-frame in the basement (34SDS). The presence of TCP and absence of BC and α-pinene in these samples indicates that they were broadleaf (deciduous) wood samples that had been exposed to chlorine.

**FIGURE 3: ADDITIONAL SAMPLES COLLECTED AT LOCATION 2 CONSIDERED BY THE IIT**

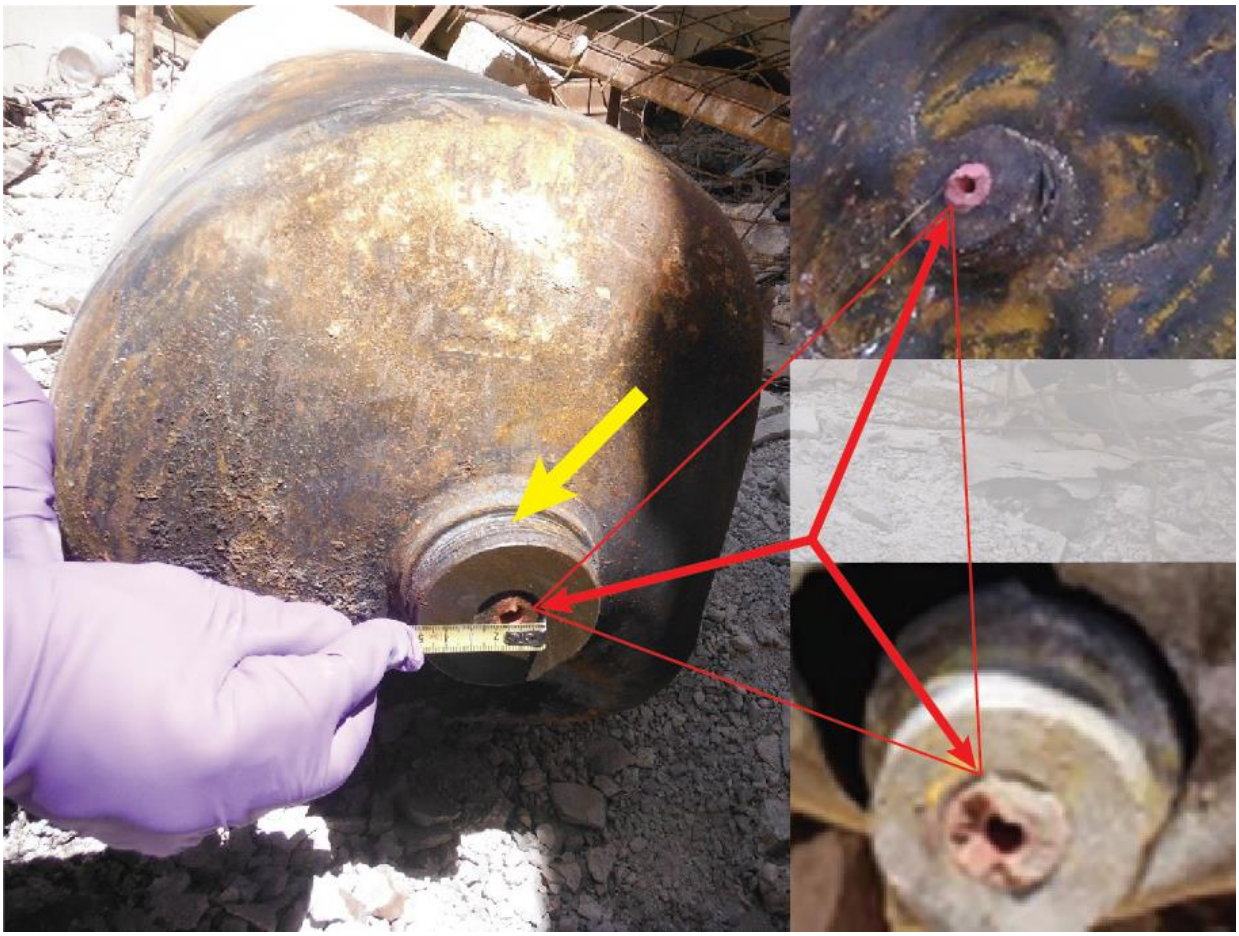
**FIGURE 10: LARGER IMAGE (SOURCE: FFM): INDUSTRIAL CYLINDER FOUND AT LOCATION 2 WITH VISIBLE VALVE WELL. THE BROKEN VALVE'S BODY (PART OF WHICH IS STILL SCREWED IN THE CYLINDER OPENING) IS MARKED WITH A RED ARROW, WHILE THE THREADS USED FOR ATTACHING THE VALVE PROTECTION CAP ARE MARKED WITH A YELLOW ARROW. SIMILAR DAMAGE OF THE VALVE (MARKED WITH A RED ARROW) IS VISIBLE ON CYLINDERS USED IN PREVIOUSLY DOCUMENTED INCIDENTS OF USE OF CHLORINE AS A CHEMICAL WEAPON E.G. IN KAFR ZEITA, 1 OCTOBER 2016[147] (SEE PHOTOGRAPH IN BLUE SQUARE) AND SARAQIB, 4 FEBRUARY 2018 (SEE PHOTOGRAPH IN RED SQUARE).[148]**

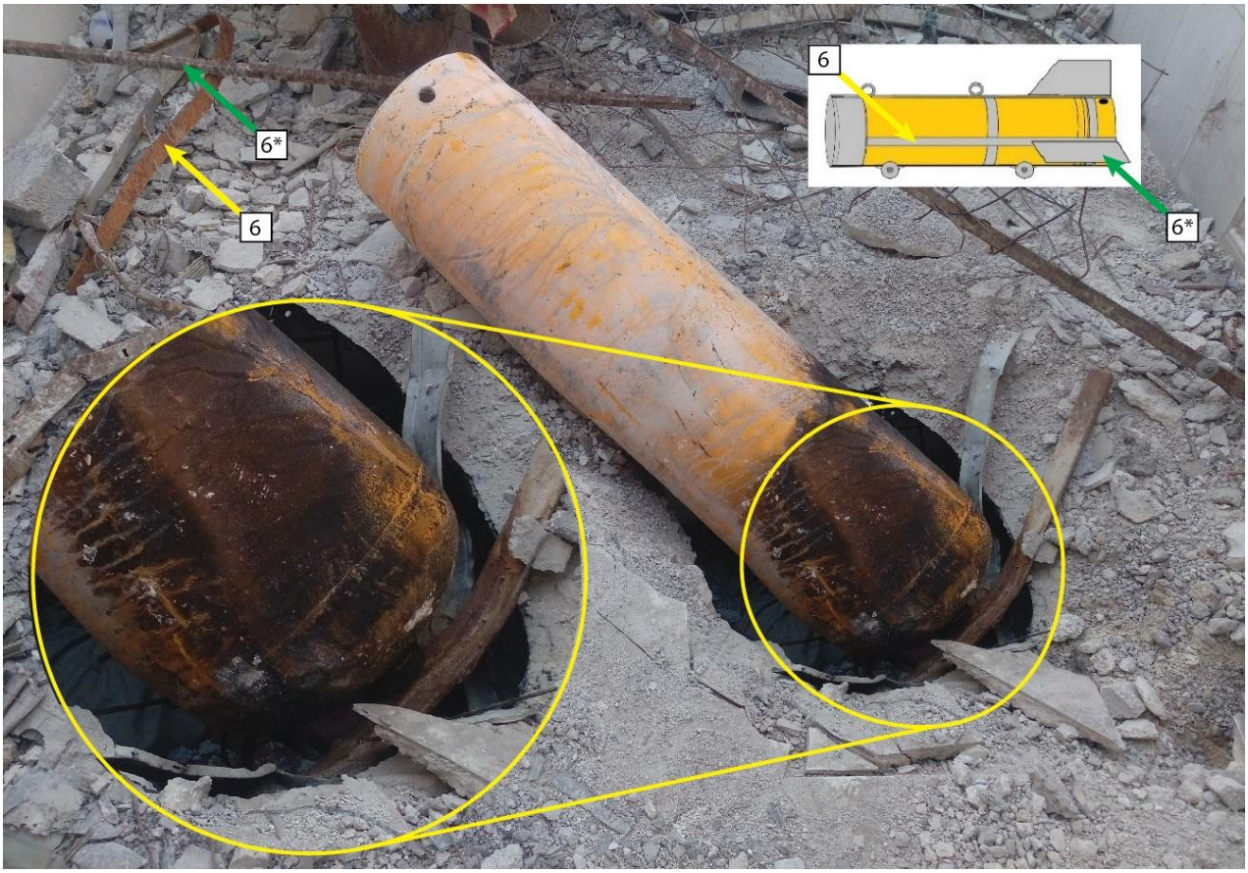
6.136 The dendritic pale-grey pattern of what appear to be dried up condensation droplets on the cylinder (observed in a picture taken on 9 April 2018) is consistent with moisture mixed with concrete dust, cement, or a similar medium. This may have been caused by the thawing of the frost formed on the cylinder, and thus further corroborates that a liquefied gas was rapidly released from the cylinder.

**FIGURE 13: THE PATTERN OF DRIED-UP CONDENSATION DROPLETS IS MARKED BY A YELLOW SQUARE (SOURCE: FFM)**

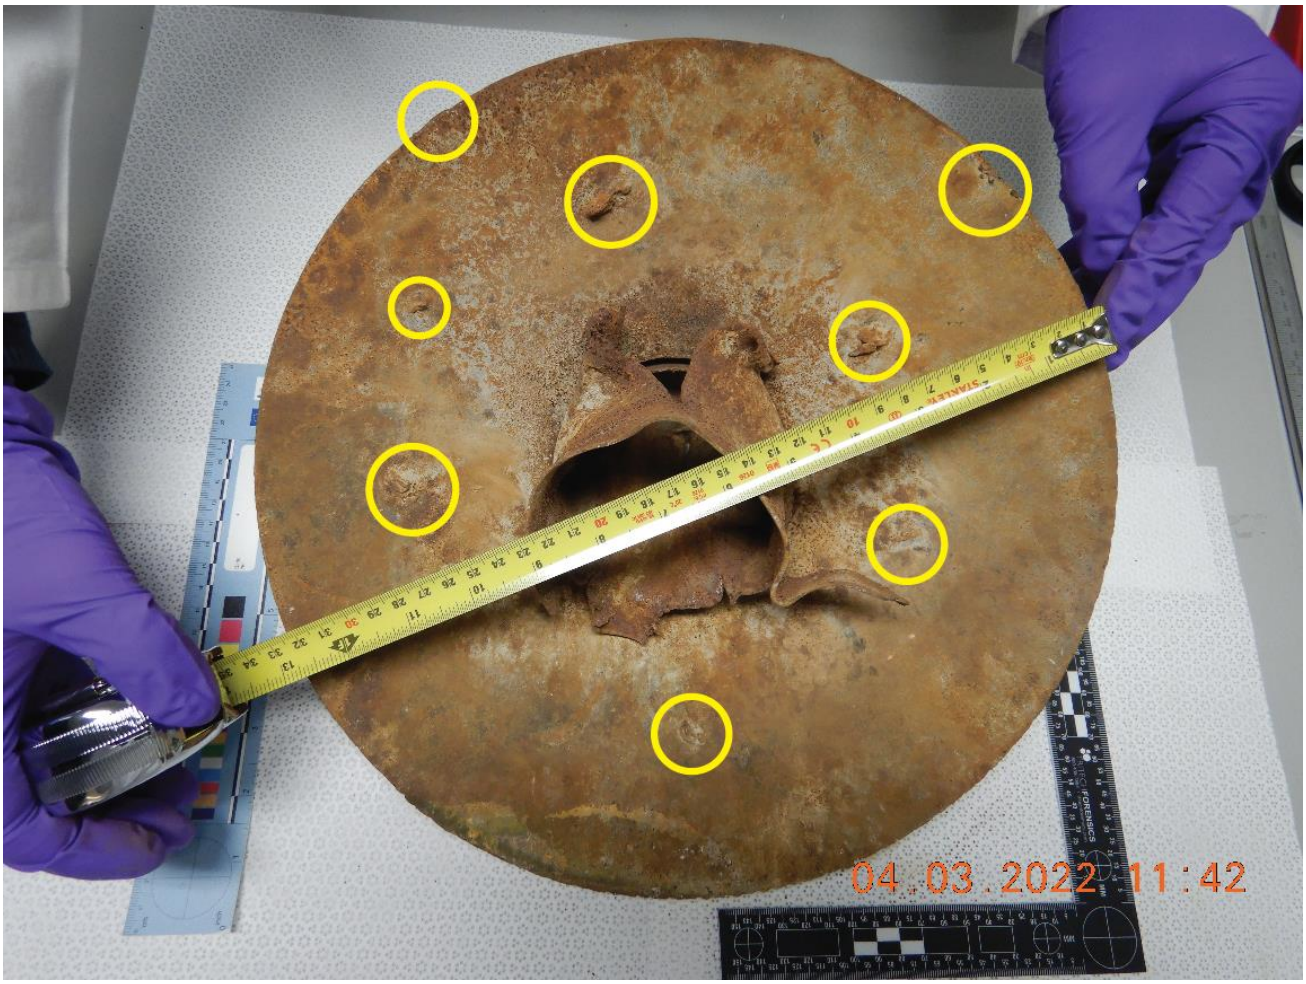
**FIGURE 15: LARGE CIRCULAR METAL PLATE, COLLECTED BY THE FFM AT LOCATION 2 ON 21 APRIL 2018 AS SAMPLE 16SDS, AND MEASURED BY THE IIT MUNITION SPECIALISTS ON 4 MARCH 2022. (SOURCE: IIT)**

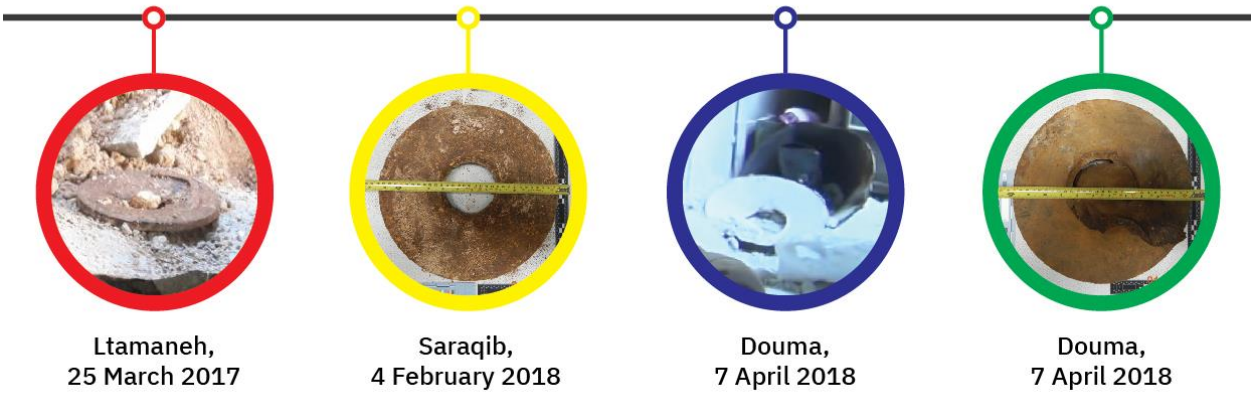
6.141 The circular metal plate is similar (i.e. material, shape, dimensions) to the circular metal plate (sample SDS12) discovered and collected in Saraqib (incident of 4 February 2018) at the location identified as Crater 2 in the Second IIT Report.[157] Welds similar to the one visible on 16SDS were also observed on the concave side of the plate and edges of SDS12.[158] A similar circular metal plate was also observed in the incident of use of chemical weapons which occurred in Ltamenah on 25 March 2017, as documented in the First IIT Report.

**FIGURE 16: COMPARISON OF METAL FRAGMENTS RECOVERED IN LTAMENAH (25 MARCH 2017), SARAQIB (4 FEBRUARY 2018), AND DOUMA (7 APRIL 2018)**

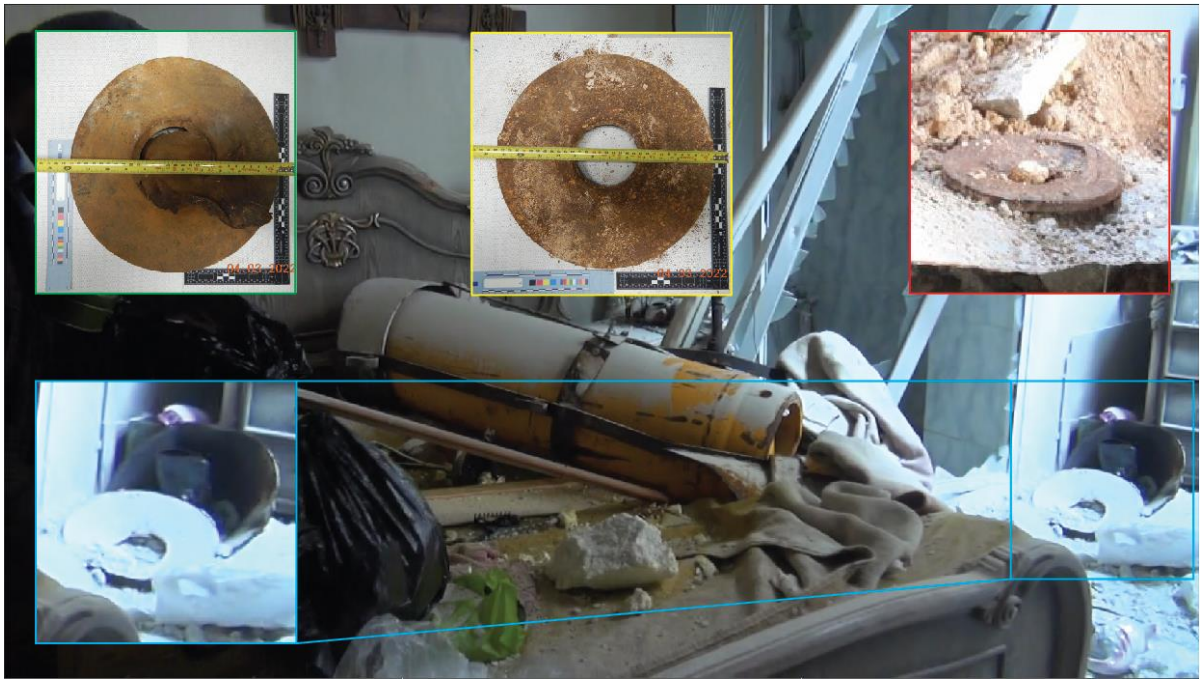
6.142 Small circular metal discs bearing close resemblance to the ones recovered in Douma at Location 2 (e.g. sample 12SDS, examined by the IIT munitions specialists and visible below) were also observed in relation to the Saraqib incident near Crater 2[159]

**FIGURE 17: METAL CIRCULAR DISC OBSERVED IN THE VICINITY OF CRATER 2 IN THE SARAQIB INCIDENT (MARKED IN YELLOW). ALSO IN THE VICINITY OF CRATER 2, ANOTHER SIMILAR METAL CIRCULAR DISC WAS FOUND (MARKED IN RED). THE SMALL METAL DISC COLLECTED BY THE FFM AT LOCATION 2 IN DOUMA AS SAMPLE 12SDS IS MARKED IN BLUE.**

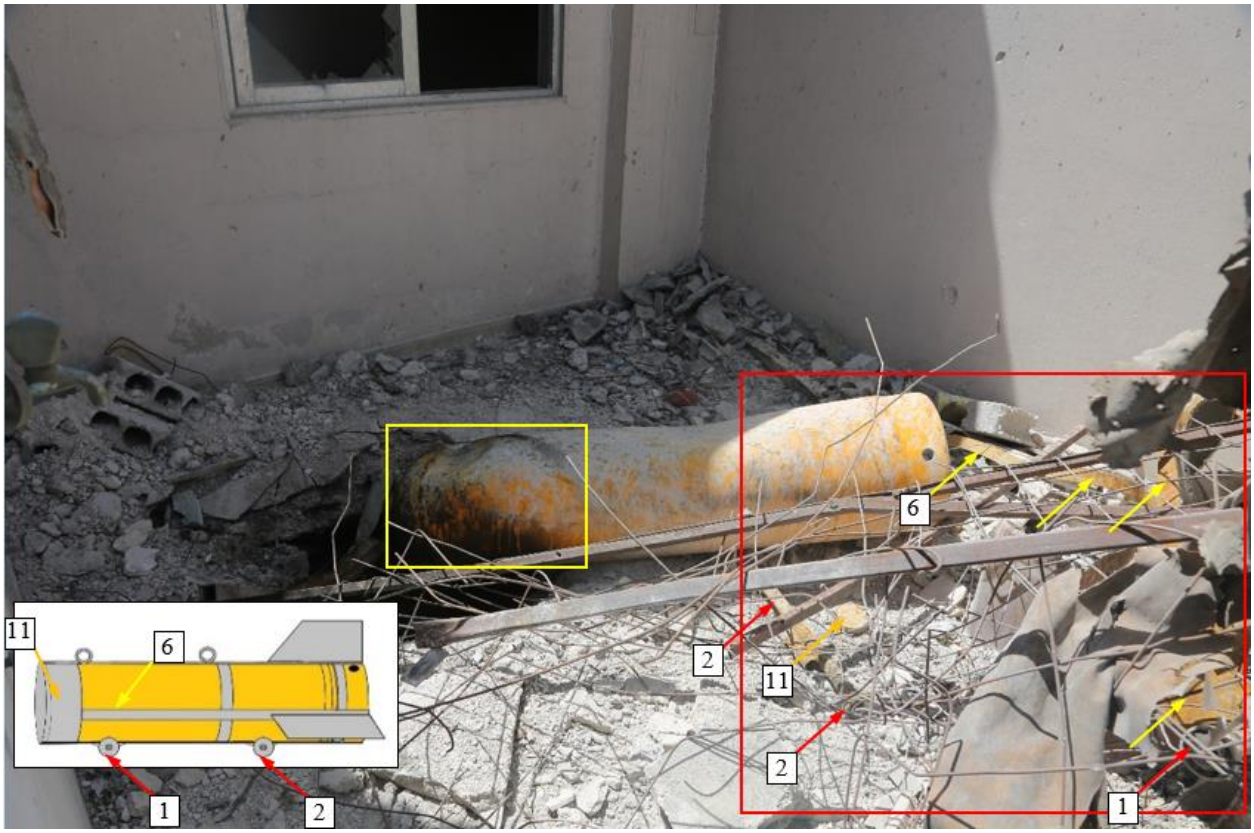
**FIGURE 19: VISIBLE IMPACT CRATER, YELLOW INDUSTRIAL CYLINDER AND THE REMAINS OF THE METAL CRADLE, PARTLY TANGLED IN THE METAL MESH ON THE ROOFTOP.**

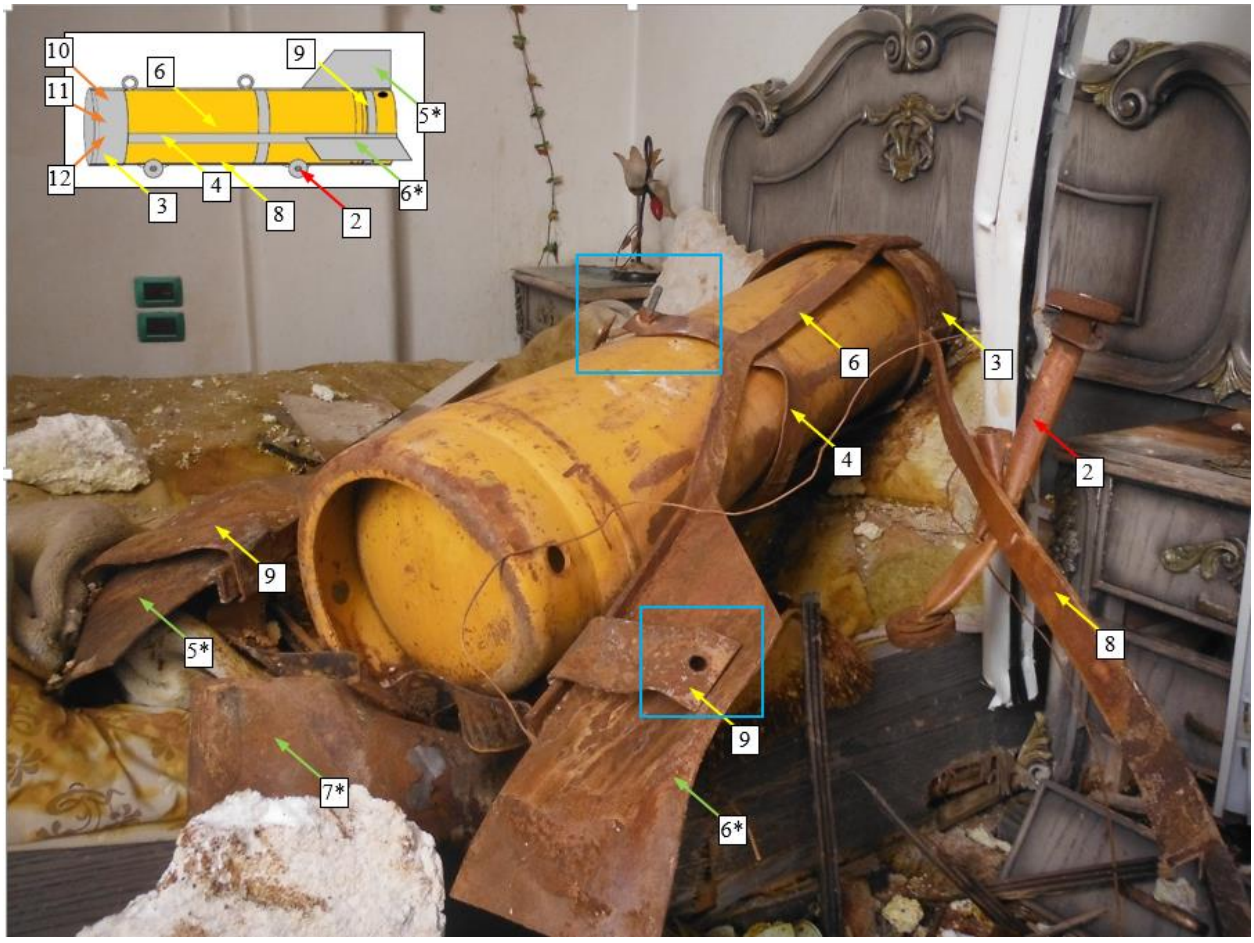
**FIGURE 20: CYLINDER ON THE BED, WITH PARTS OF THE CRADLE CLEARLY VISIBLE (SOURCE: FFM)**

6.150 One side of the cylinder is visibly flattened.[164] The overall deformation of the cylinder and cradle (i.e. flattening on one side and bending of the fins) is consistent with the deformation pattern that was calculated through dynamic simulations by external experts consulted by the IIT.

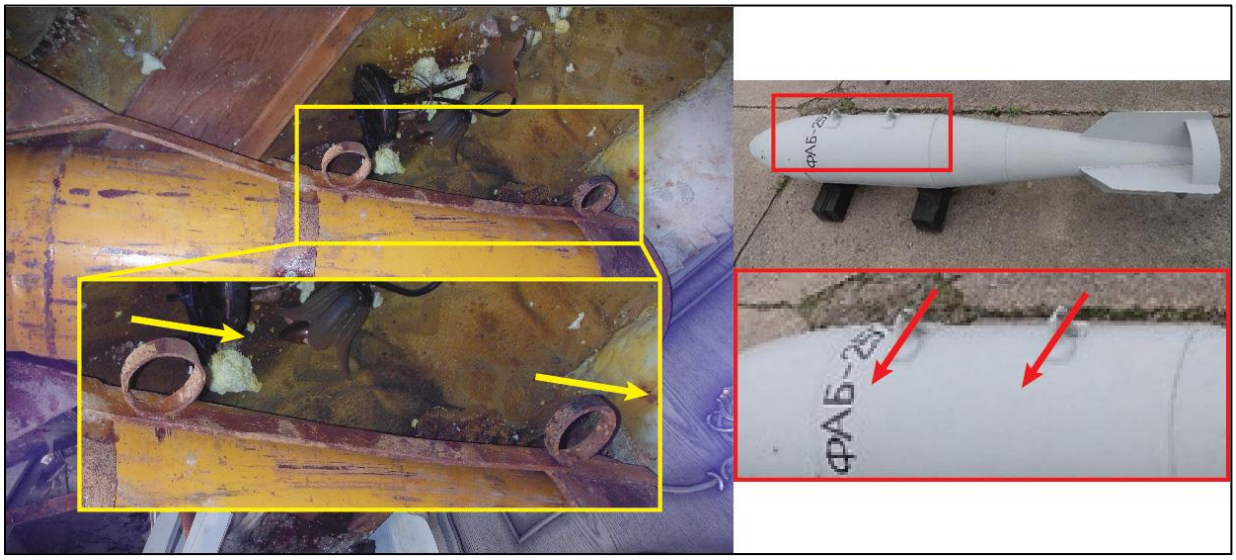
**FIGURE 25: ON THE LEFT: LIFTING LUGS ON THE CRADLE ATTACHED TO THE CYLINDER FOUND AT LOCATION 4 (MARKED WITH A YELLOW SQUARE); ON THE RIGHT: LIFTING LUGS ON AN FAB-250 AERIAL BOMB (MARKED WITH A RED SQUARE). THE DIRECTION OF THE LIFTING LUGS ON THE CRADLE PREVENTS ITS ATTACHMENT ONTO CONVENTIONAL AIRCRAFT WEAPON PYLONS.**

6.167 Rather, the lugs appear to be intended to facilitate the handling of the cylinder.

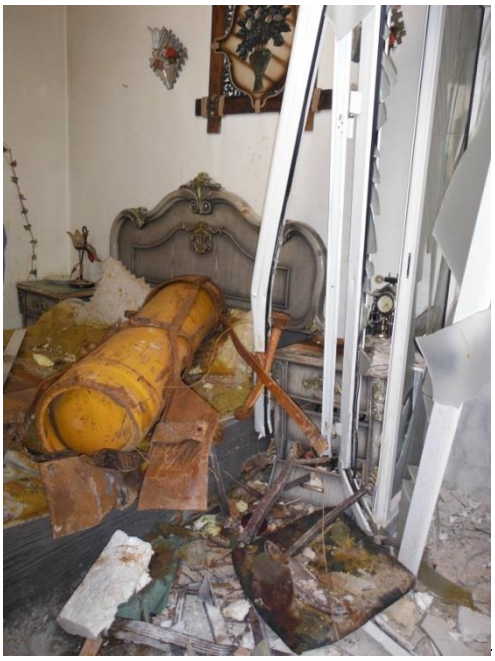
**FIGURE 30: CYLINDER ON THE BED AT LOCATION 4.**

6.205 The figure above shows an elongated hole in the roof above the bedroom at Location 4.

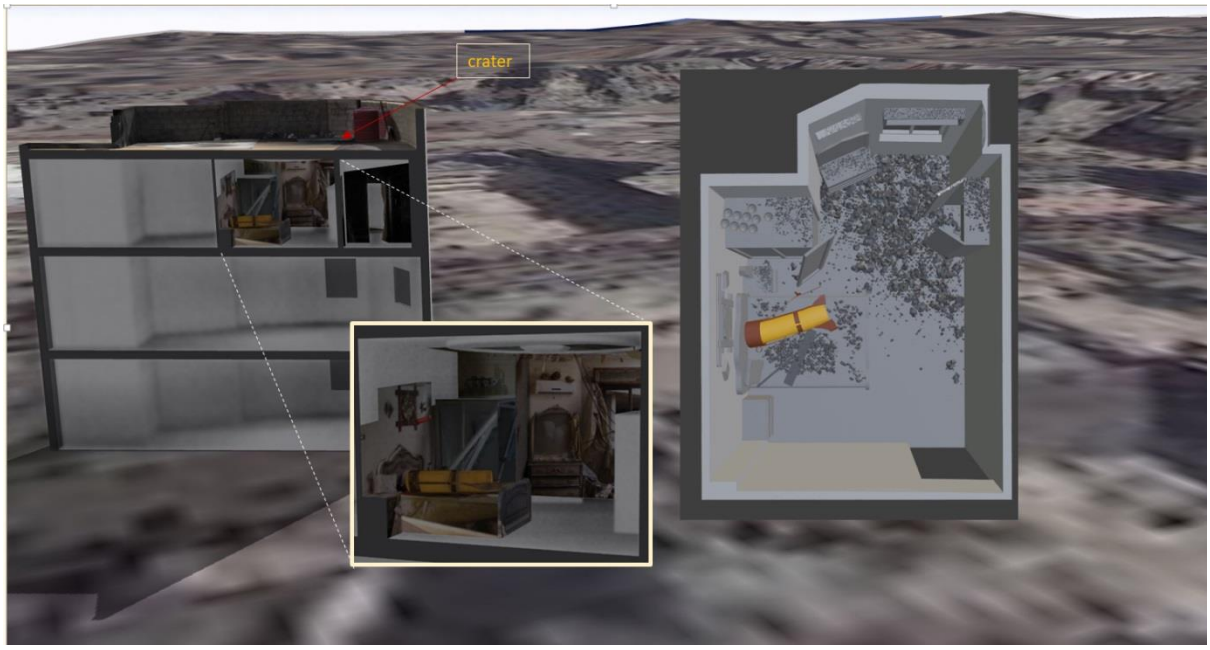
6.208 The hole is not located above the bed where the cylinder was found. Instead, it is near the south-western corner of the room, diagonally opposite the corner on the left of the bed's headboard.

**FIGURE 34: POSITION OF THE CRATER AT LOCATION 4 IN RELATION TO THE BED'S HEADBOARD**

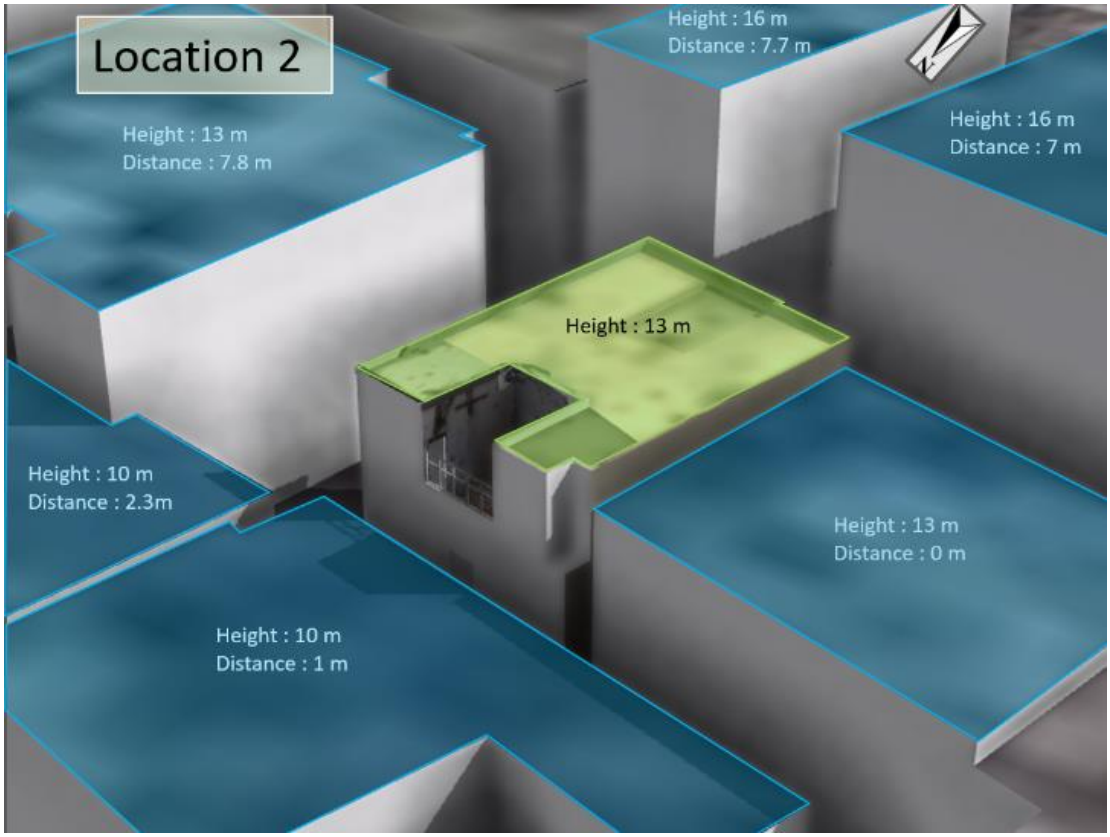
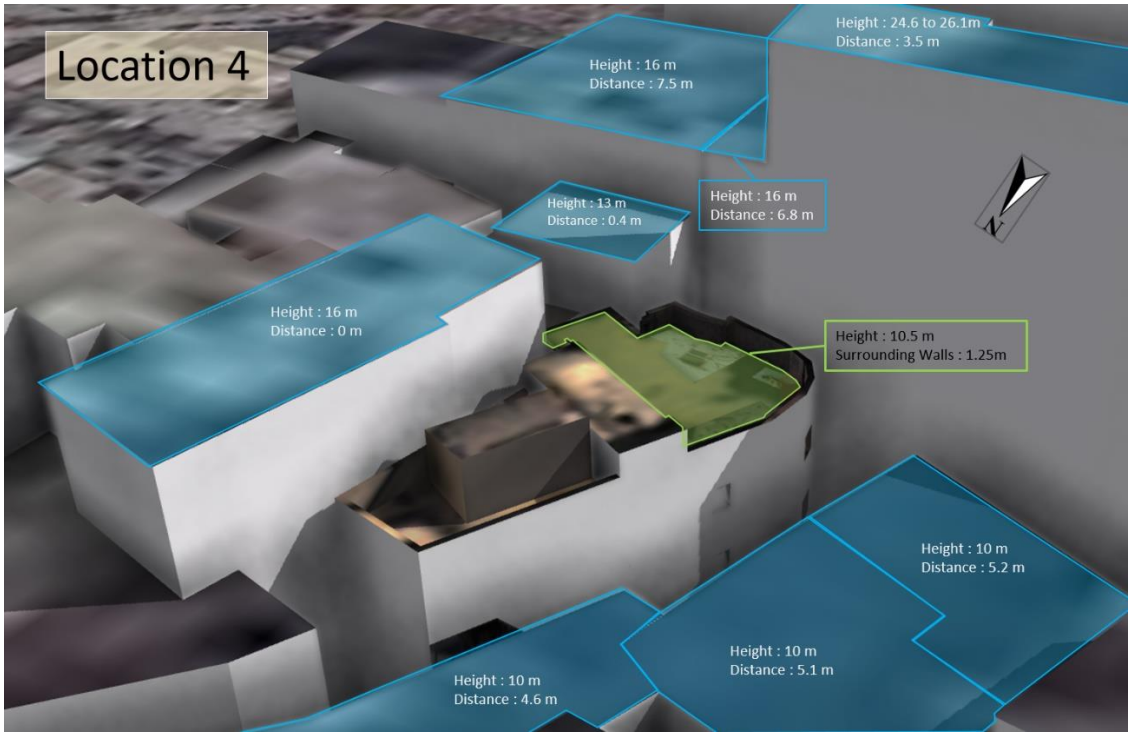
**FIGURE 35: 3D VISUALISATION OF HEIGHTS AND DISTANCES OF ADJACENT BUILDINGS TO LOCATIONS 2 AND 4**

6.211 As noted above, experiments were also commissioned from specialised external institutions, including to assess the possibility that the cylinders may have been thrown from adjacent buildings (the height of which was also independently determined by the IIT via 3D reconstruction from satellite images).

6.212 A first set of experiments was conducted to assess the deformation caused to a replica cylinder and cradle when dropped from a height of 16 m (i.e. the estimated height difference between the crater at Location 4 and the highest adjacent building) and impacting a replicated concrete roof structure. A second set was conducted to examine the damage caused to the roof structure itself by the impact of the cylinder and cradle dropped from 16 m. These replicates were built based on information and photographs provided by the OPCW.

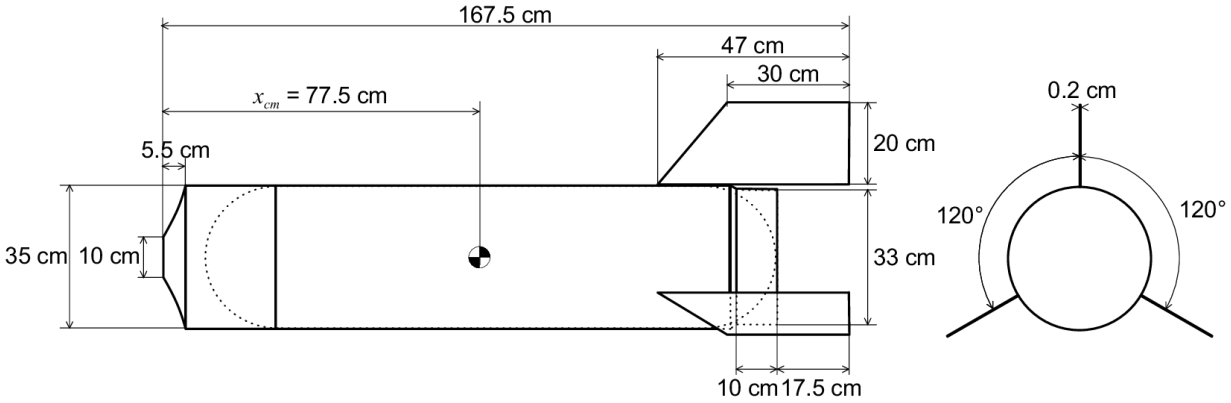
**FIGURE 39: RECONSTRUCTION, WITH MEASUREMENTS, OF THE CYLINDER'S ASSEMBLIES FOUND IN DOUMA, AS USED IN THE SIMULATIONS PERFORMED BY THE MISSILE TRAJECTORY EXPERT CONSULTED BY THE IIT**

6.230 However, the model acknowledges—and accounts for the fact that—some elements of uncertainty remain, and that, at both locations, it is impossible to determine the exact configuration of the assembly prior to impact.

6.231 For instance, at Location 2, the cradle appears to have detached upon impact and was found mangled next to the cylinder.

6.232 As noted above, at Location 4 the cylinder seems to have shifted forward relative to its support cradle. Due to the damage, the length of the pipe through the front plate and of the metal strips that connect the nose cap to the tail fins (and thus the exact overall length of the assembly) is unknown.

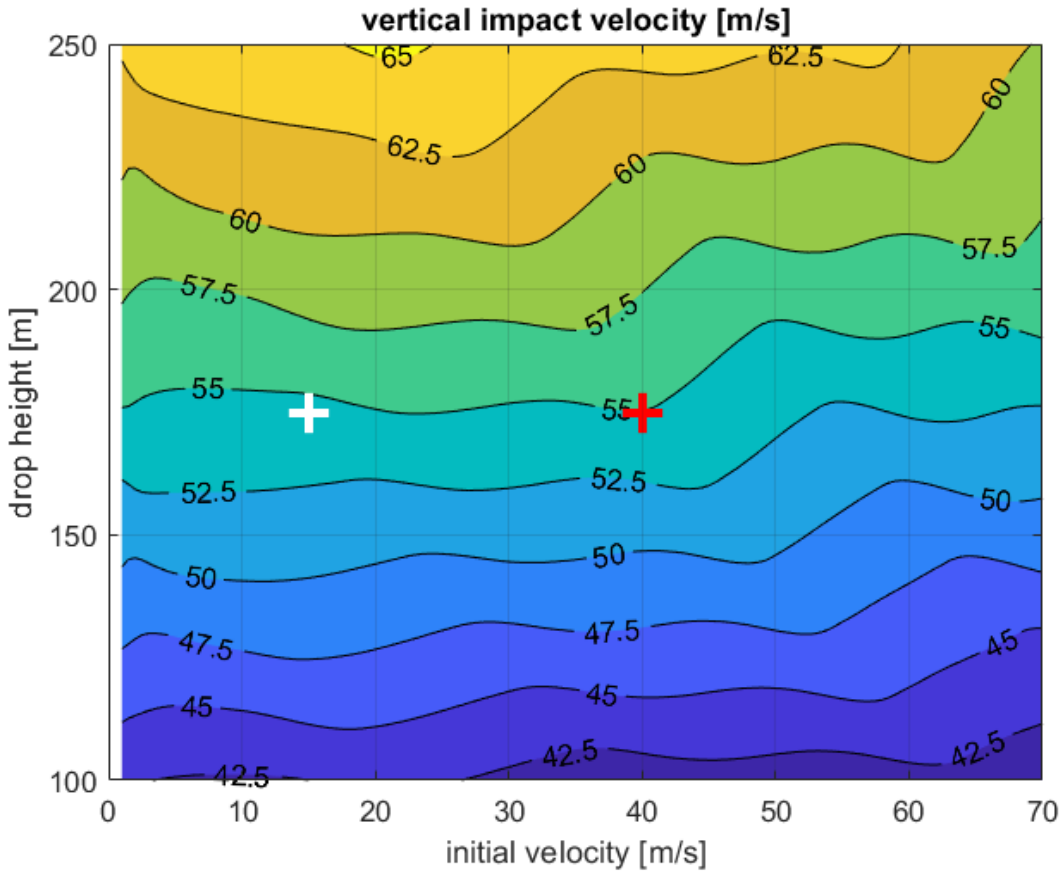
6.257 The figure above shows that vertical impact velocities between 50 and 60 m/s (indicated in the figure by the relevant contour lines) correspond to drop heights between 140 m and 250 m depending on the initial horizontal velocity. This is in line with the minimum drop heights determined in the expert reports commissioned by the FFM.

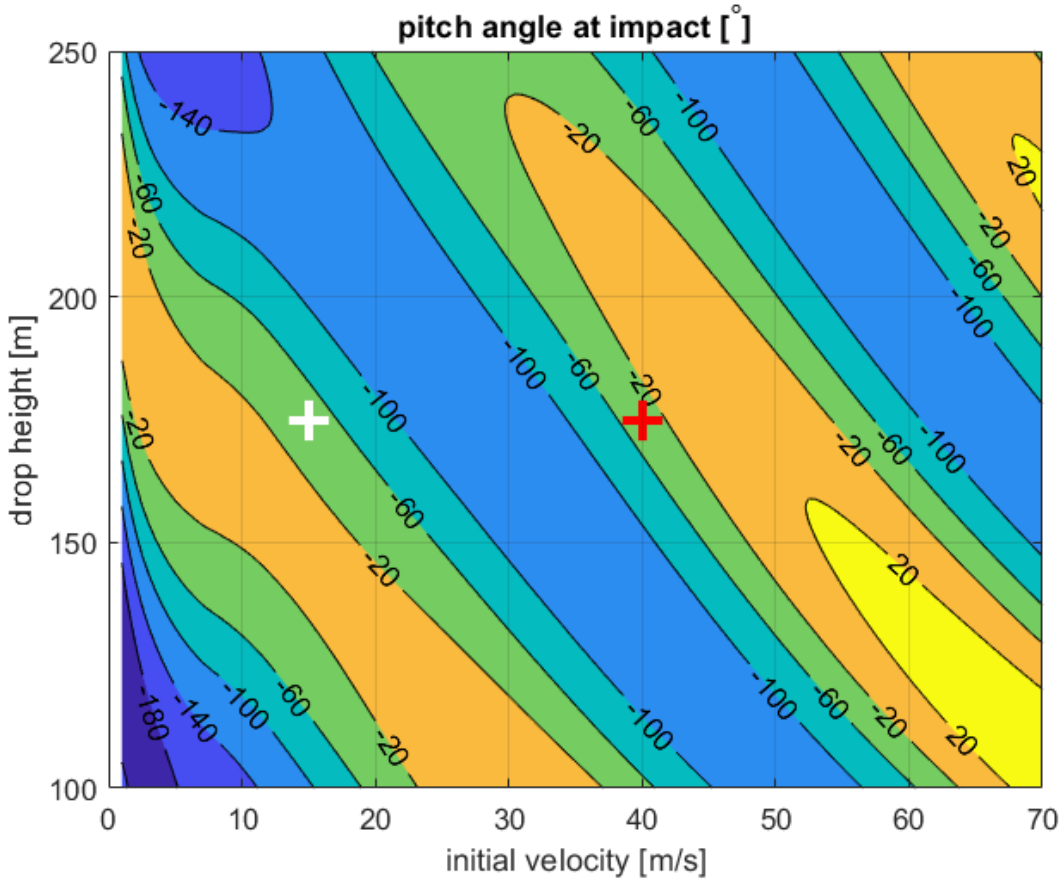
6.259 At Location 2, provided that the cylinder impacted the rooftop floor directly,[229] the pitch angle at impact was -45°,[230] with an impact velocity of 55 m/s. This corresponds to a drop height close to 175 m. The figure above further illustrates that for that drop height, initial velocities consistent with a pitch angle at impact of -45° are close to 15 m/s (white marker) and 40 m/s (red marker).

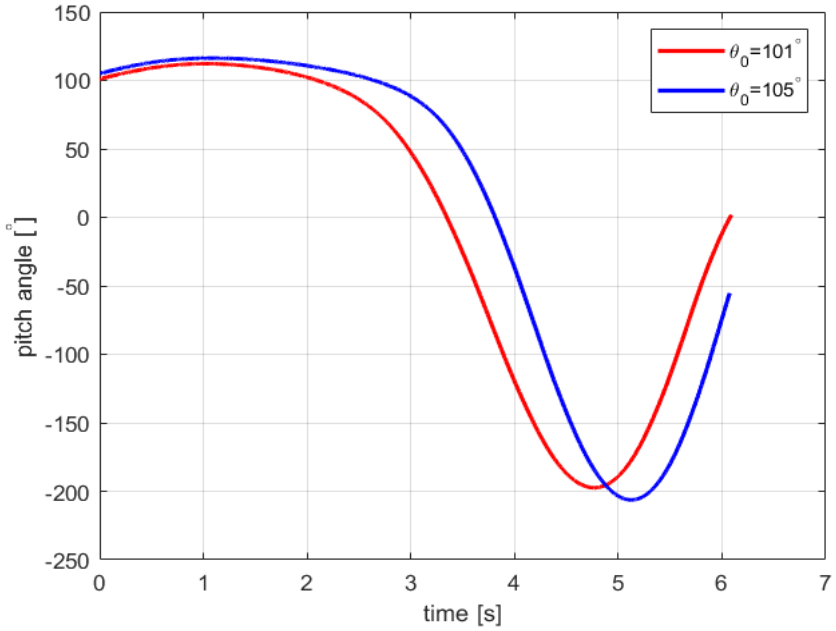
**FIGURE 44: THE PITCH ANGLE AS A FUNCTION OF TIME FOR A DROP HEIGHT OF 175 M, AN INITIAL VELOCITY OF 10 M/S, AN INITIAL PITCH RATE OF 20°/S AND TWO INITIAL PITCH ANGLES OF 101°AND 105°.**

6.263 More specifically, the chart above shows two simulation results for which the drop height (i.e. 175 m), the initial horizontal velocity (i.e. 10 m/s) and the initial pitch rate (20°/s) of a cylinder with the same properties as the ones found in Douma are identical. The only value that varies is the initial pitch angle.

6.264 A horizontal impact, such as the one established for the cylinder at Location 4, requires an initial pitch angle of 101°. However, a slightly larger initial pitch angle (e.g. 105°) would suffice for the cylinder to impact nose-down instead, as was the case at Location 2.

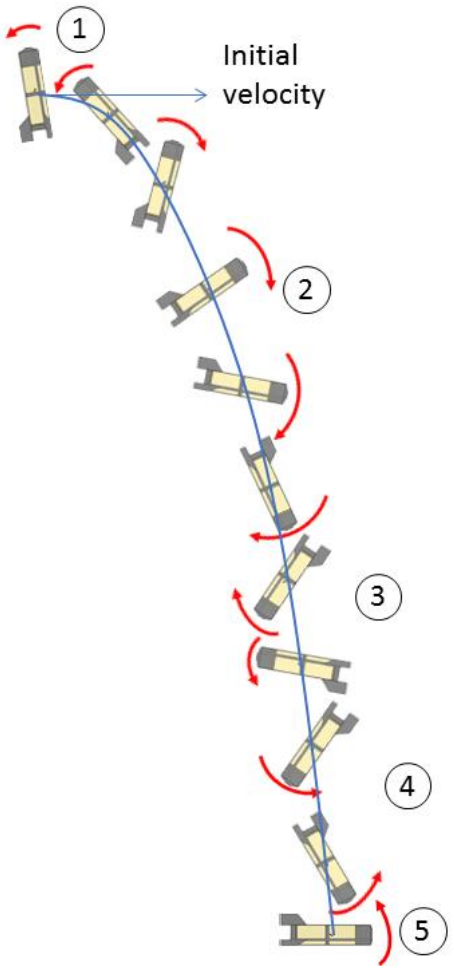
6.266 Due to the positive initial pitch rate and inertia, the cylinder's pitch angle increases at first, even for a cylinder that is assessed to be stable. For low initial velocities, the flight path angle drops very quickly, while the angle of attack increases rapidly. This results in the cylinder pointing backwards in about two seconds, and getting very close to tumbling. However, because the cylinder is stable, the aerodynamic forces acting upon it push its nose down. Then, again due to inertia, the angle of attack overshoots and, about five seconds after having been dropped, the cylinder briefly flies up-side down, after which its nose pitches back up, with the cylinder still swinging upon impact.

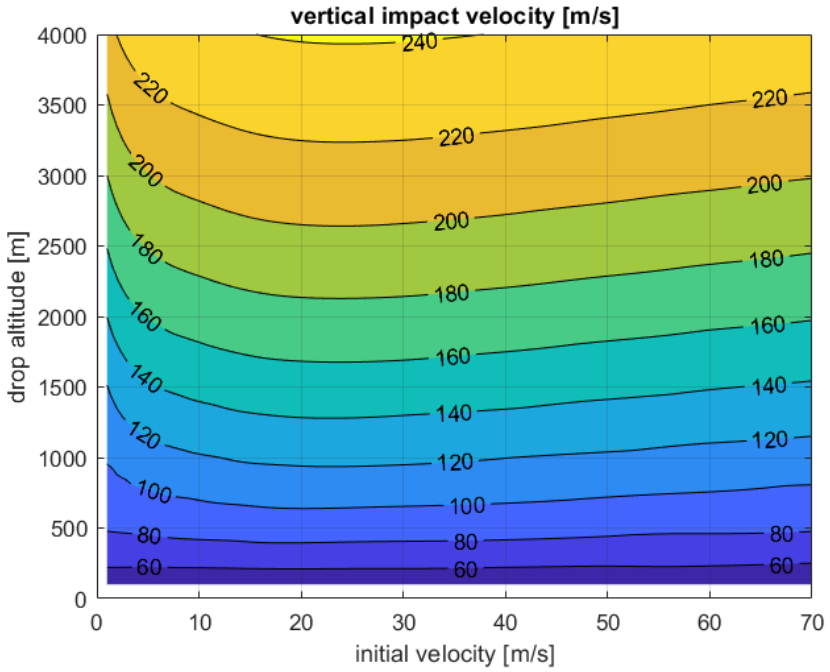
**FIGURE 46: VERTICAL IMPACT VELOCITY AS A FUNCTION OF THE INITIAL VELOCITY AND DROP HEIGHT FOR AN INITIAL PITCH ANGLE OF 90° AND A 0°/S PITCH RATE**

6.270 For Location 4, an impact velocity of 125 m/s would have resulted in the cylinder penetrating the roof and also, partially, the floor of the bedroom underneath.

6.271 Based on the figure below, this would have been possible from a height of about 1,000 m.

6.272 Since the cylinder at Location 4 did not, in fact, breach the bedroom floor, the maximum height at which the cylinder could have been dropped is below 1,000 m.

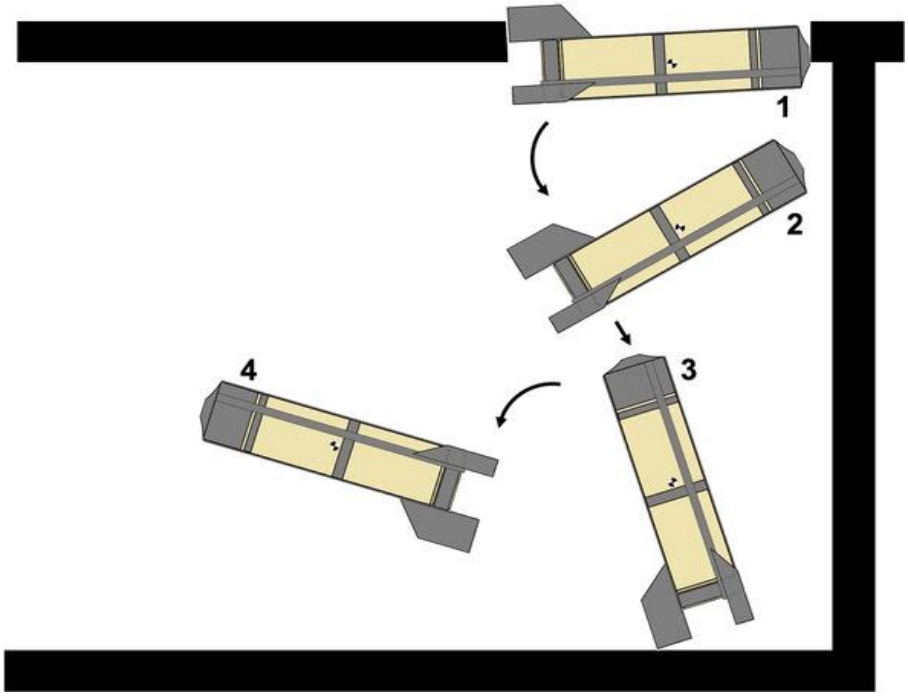
**FIGURE 48: POSSIBLE MOTION OF THE CYLINDER IN THE VERTICAL PLANE**

explain why the orientation of the cylinder on the bed is opposite to its orientation on impact (about 180$^{o}$).

6.296 Evidence of the rotation of the cylinder in the bedroom after impact is that the wardrobe is only damaged at the top, most likely because of debris from the crater above. However, the side of the wardrobe was undamaged, which indicates it was not directly hit by the cylinder. Furthermore, the damage visible on the shower unit is consistent with it having been impacted by parts of the cradle.

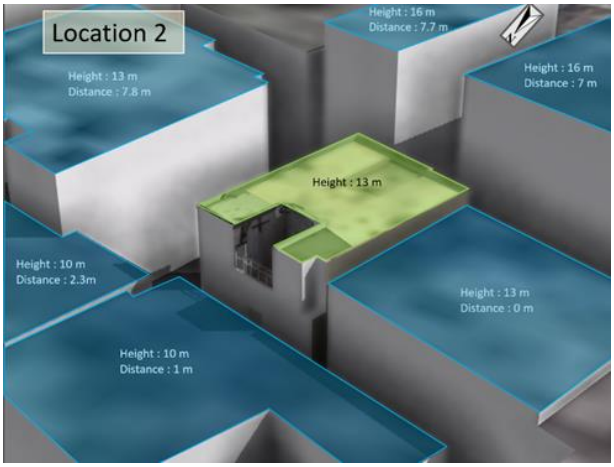
**FIGURE 53: 3D RECONSTRUCTION OF BUILDINGS ADJACENT TO THE BUILDING AT LOCATION 2.**

6.302 Similar reasons led the IIT to discard the hypothesis (which it duly considered and pursued in the course of its investigation)[250] that the cylinders may have been dropped manually from buildings adjacent to Locations 2 and 4 respectively. Through the analysis of 3D building reconstruction from satellite images, the IIT was able to determine that at Location 2, there was no higher building adjacent to the building where the cylinder was found.

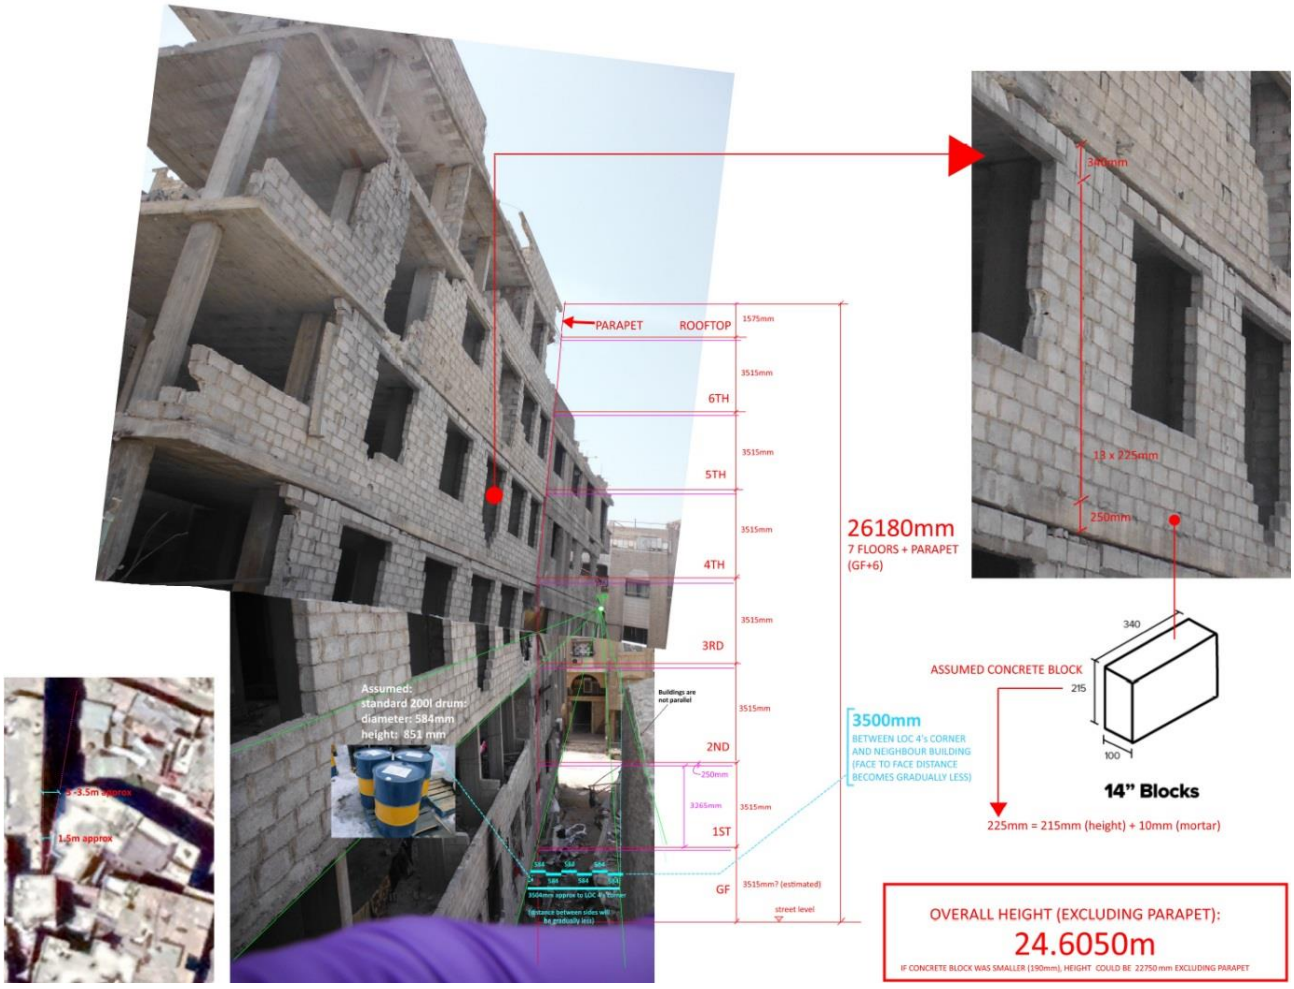
**FIGURE 54: HEIGHT AND DISTANCE ESTIMATIONS AT LOCATION 4**

6.303 At Location 4, there was one higher building sufficiently close (between 2.37 m and 3.5 m)[251] from which a cylinder may have been dropped. However, as the difference in height is only between 14.1 and 15.6 m, a drop from this building would not explain the damage assessed at Location 4.
